CHEN RESIDENCE – DEEP POINT FARM

VARIANCE PACKAGE – BUFFER VARIANCE REQUEST

LOCAL CASE #22-28

4833 Deep Point Drive, Chestertown, MD, 21620

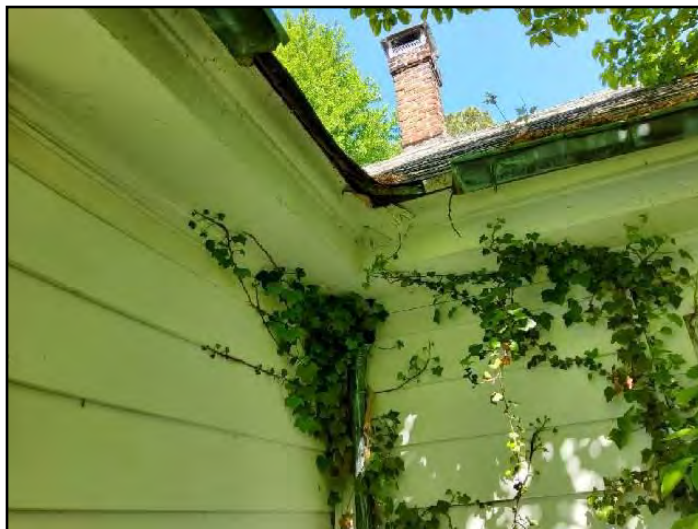
4.

3. Condition: • The exterior has various repairs needed such as flaking trim paint, rot on trim and soffit/rake board, grading needs improved, etc. Recommend an exterior contractor evaluate and repair.

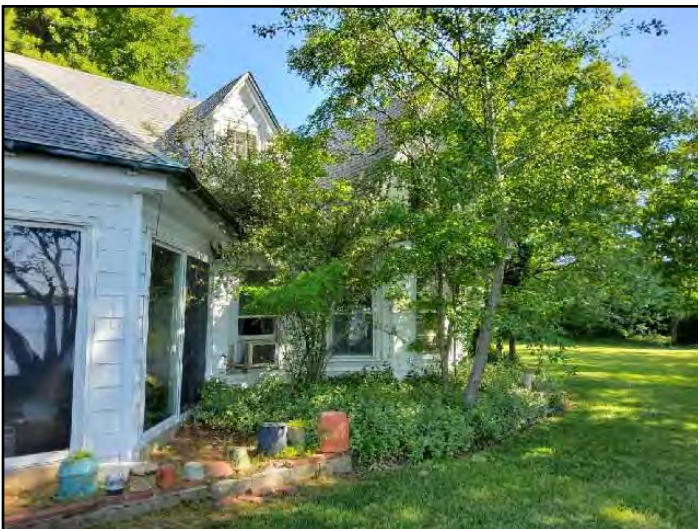
7.

5. Condition: • Trim back vegetation away from the house and equipment.

This includes removing any trees near the foundation as needed and remove vines from the house.

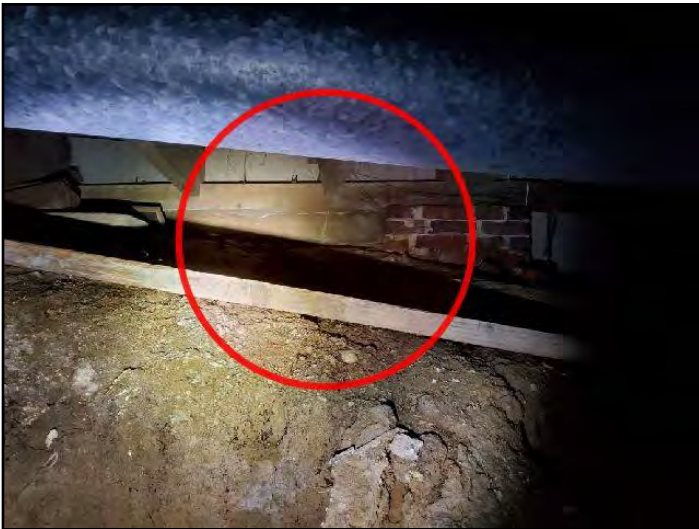
12.

10. Condition: • The sill on much of the house is a structural component and is rotted in some areas and sagging in others as seen from the interior and exterior, joist and beam sag, termite tubes noted on right side, improper and rusted supports, and more. Interior floors have sagging as well but not all crawlspace areas below are accessible. Recommend a contractor evaluate overall framing and repair.

Task: Further evaluation and repair

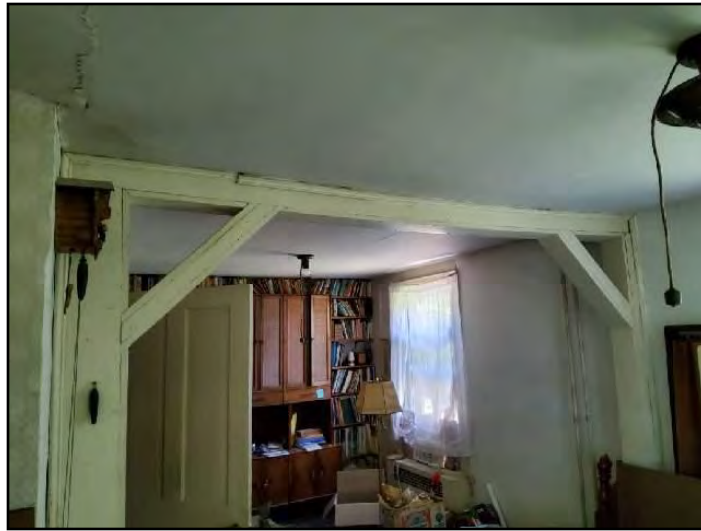
21.

13. Condition: • Sag

The ceiling in the far right sunroom are sagging but cannot view framing to evaluate the cause. Recommend evaluate and repair

Task: Further evaluation and repair

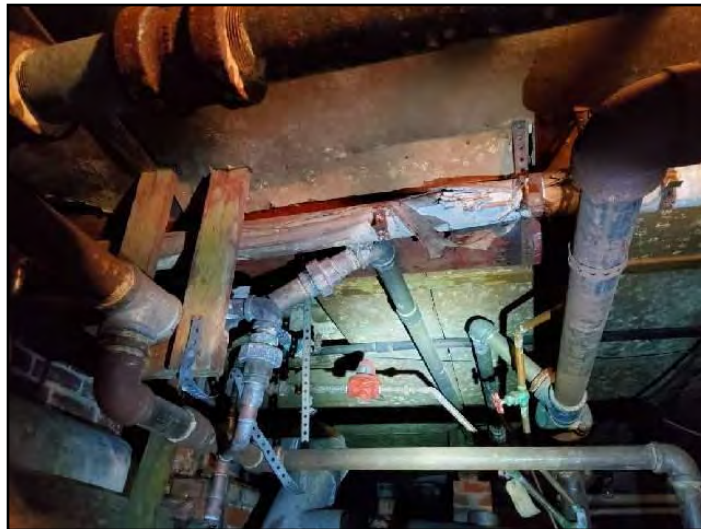
48.

37. Condition: • The pipe wrap above the boiler and possibly other materials may contain asbestos. Recommend a professional properly remove.

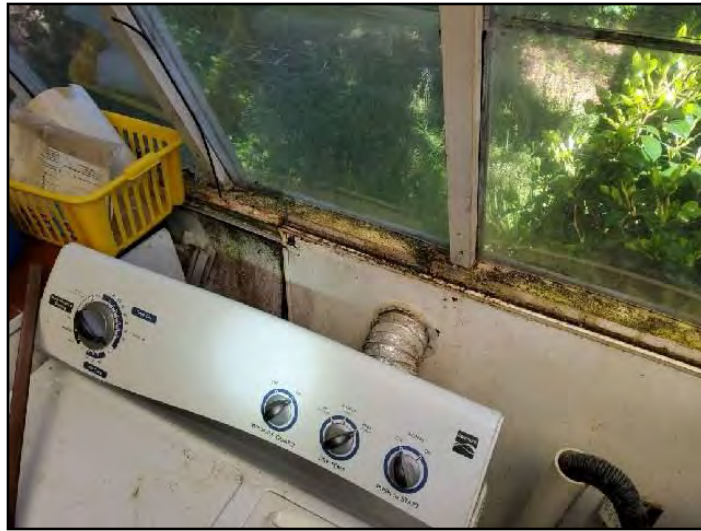
49.

38. Condition: • The laundry room walls are not flashed or sealed on the outside and have water damage, with possible mold present. Recommend repair

Location: Laundry area

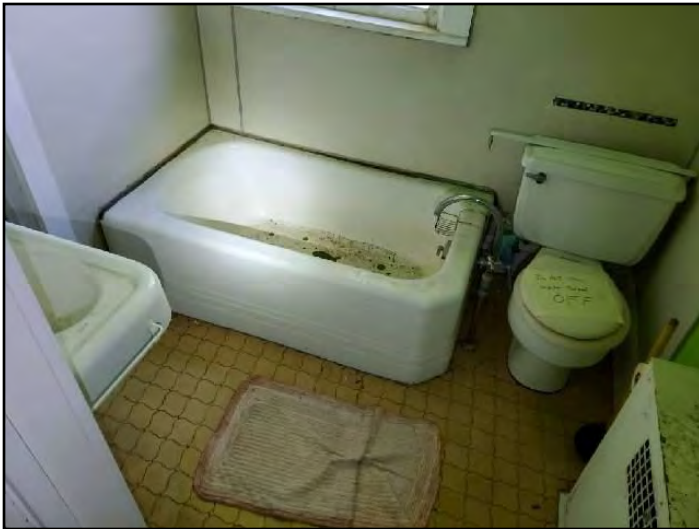
50.

39. Condition: • There are various defects that may not be reported that are more cosmetic in nature and apparent to anyone walking through the home. Overall cosmetics and updating needed. Repair as needed.

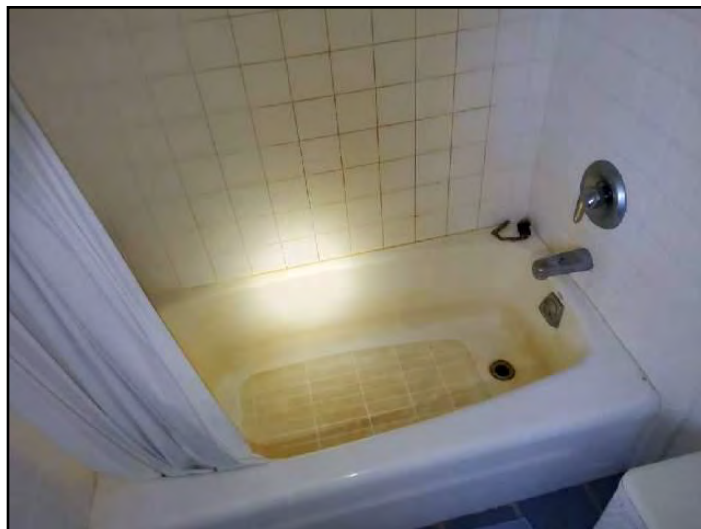
46.

32. Condition: • Staining in the plumbing fixtures of the apt may indicate need for additional water treatment. Recommend evaluating

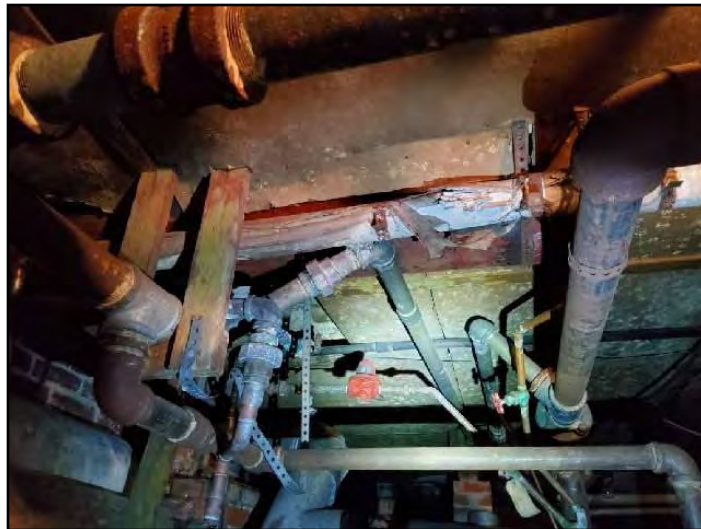
48.

37. Condition: • The pipe wrap above the boiler and possibly other materials may contain asbestos. Recommend a professional properly remove.

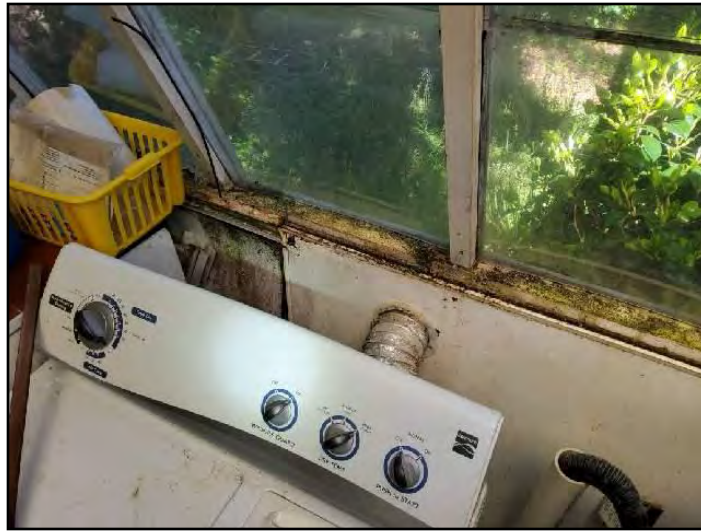
49.

38. Condition: • The laundry room walls are not flashed or sealed on the outside and have water damage, with possible mold present. Recommend repair

Location: Laundry area

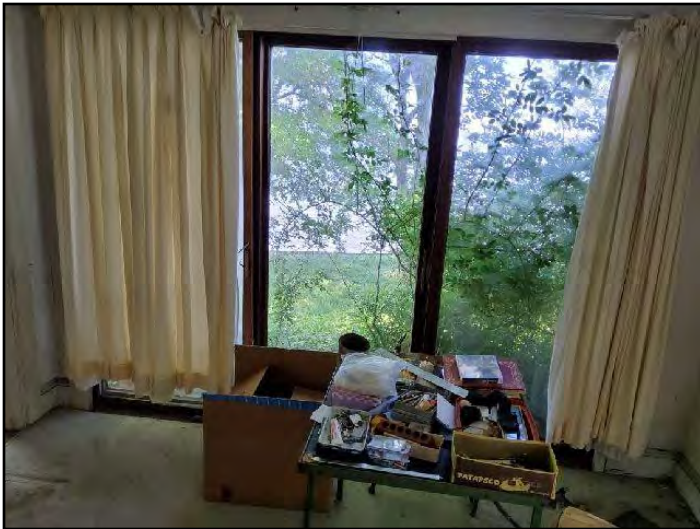
61.

43. Condition: • The old sliding doors in the front and right have water staining on the interior and lost seal between panes. Others have been replaced. Recommend replace older doors.
