Discussion of the current condition and proposed next steps for Turners Creek Granary:

**GREDELL
& ASSOCIATES**
STRUCTURAL ENGINEERS

March 23, 2009

WO 2810
STRUCTURAL CONDITION ASSESSMENT
THE GRANARY
TURNER'S CREEK PUBLIC LANDING
KENNEDYVILLE, MARYLAND

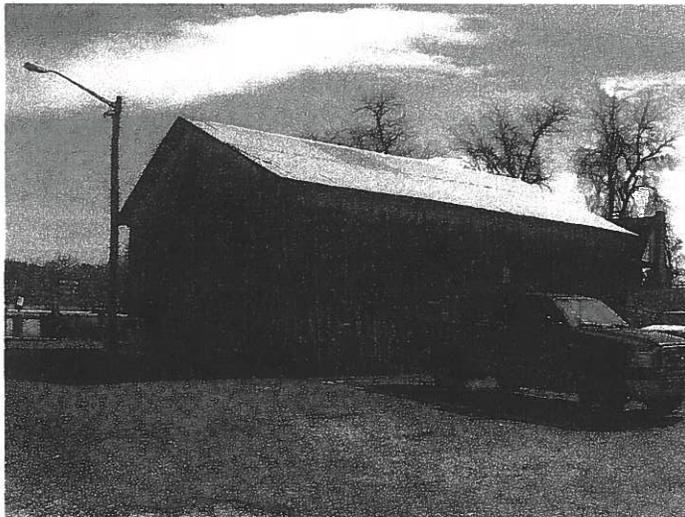
*The Granary, Turner's Creek Public Landing, Northwest Elevation
Gredell & Associates 12 March 2009*

The Granary is a two story, timber frame storage building constructed mid to late 1800's. The building is rectangular in plan measuring approximately 34 1/2' east-west and 46' north-south. The building rises over a shallow crawl space approximately 15' to the eave line of a gable form roof where the ridge runs north-south. The floor plan is a double loaded, narrow, central, north-south running central corridor double loaded with grain bins, east and west and open floor space at the second level.

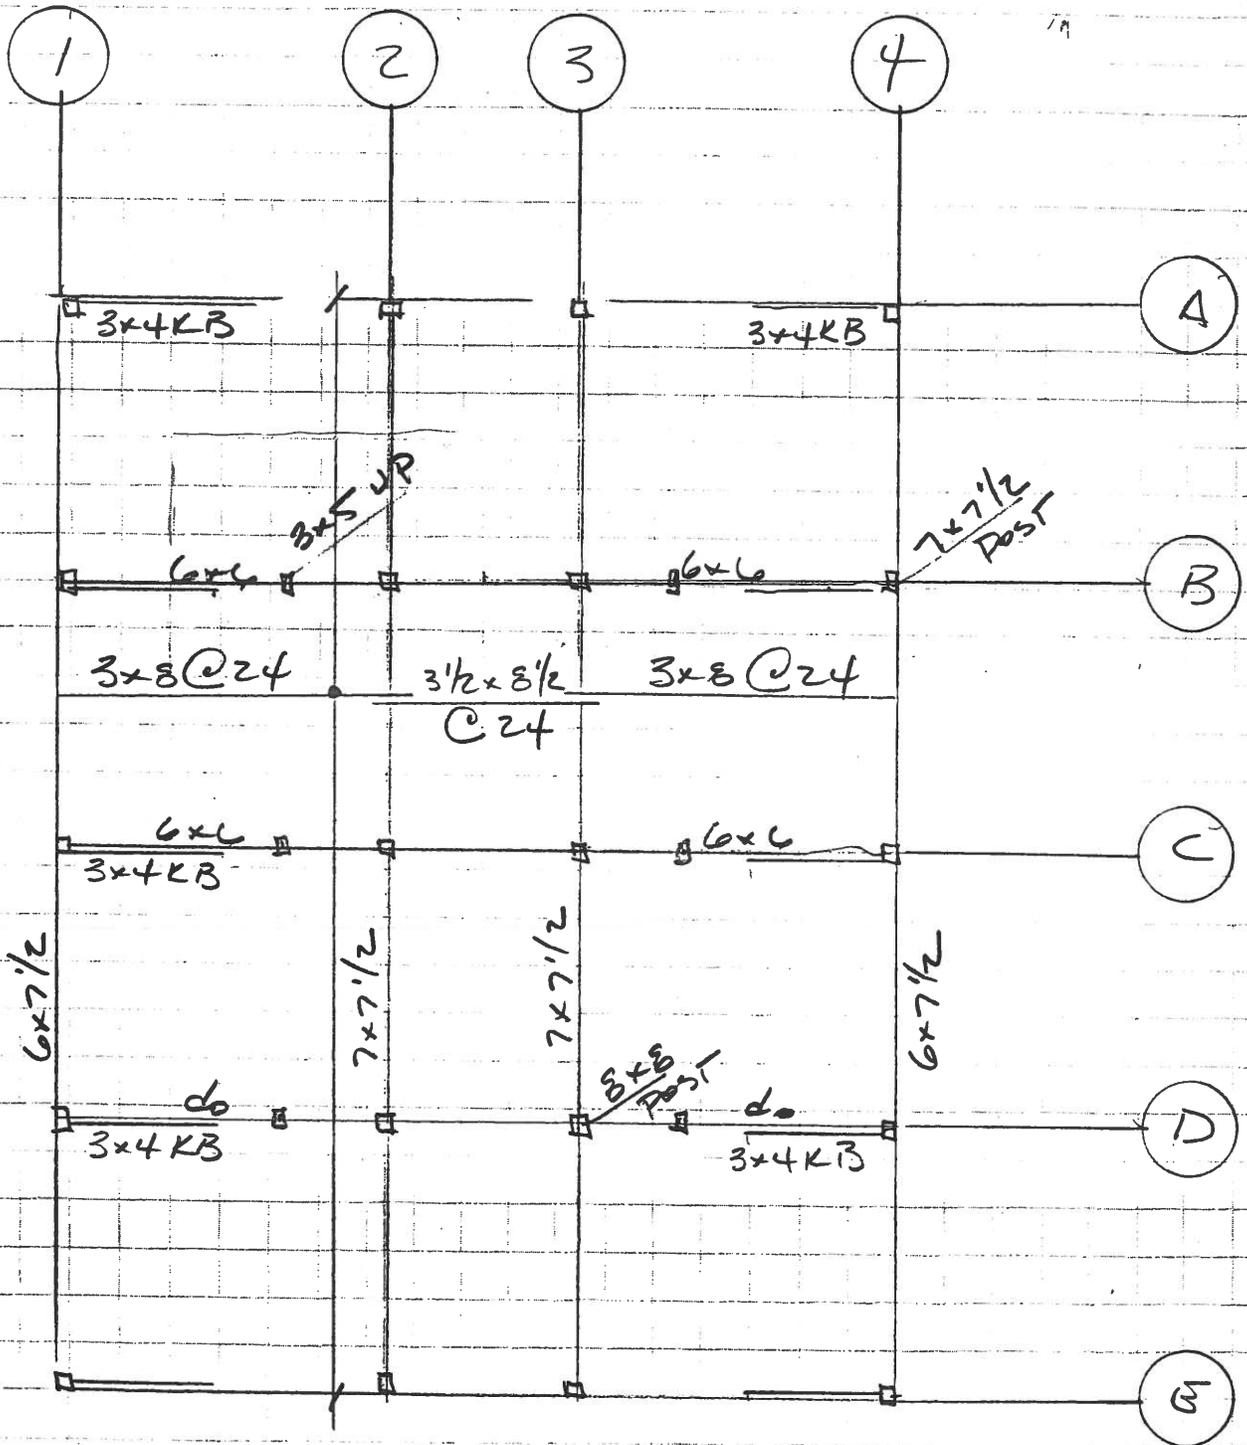
SECOND FLOOR FRAMING

- The second floor is framed with 3x8@24" joists spanning east-west and bearing on timber beams 7x8 ("2", "3") and 6x8 ("1", "4"). Except for the deterioration that has occurred at the northwest corner of the building adjacent to post "A1", the structural condition of the second floor framing appears good.

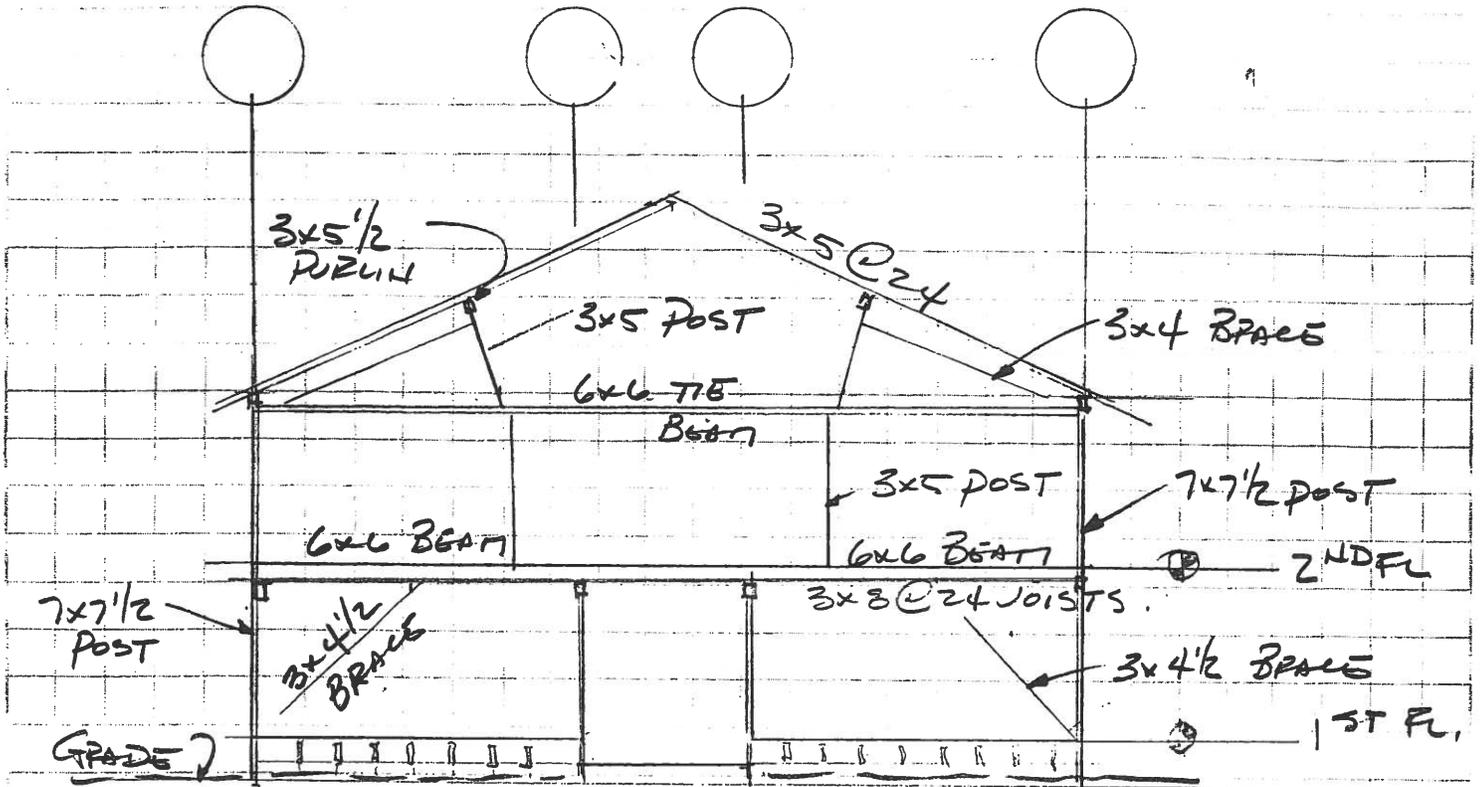
Section
1/8" = 1'-0"

- The primary structure of the gable form roof is comprised of 3x5 1/2 timber purlins spanning north-south and 3x5 rake posts set on 6x6 tie beams located at the three interior bent locations. The roof loads are transferred to the second floor 6x6 tie beams at the second floor with 3x5 posts located near the rake posts that support the purlins. Knee bracing 3x4 1/2 provides lateral stability for the structure. Rafters 3x5@24" overframe the purlin and the eave beam. At the ridge the rafters are plumb cut and meet with a simple butted joint. Purlin splicing is

achieved with half lap, pinioned scarf joints made adjacent to the knee bracing. The structural condition of the roof appears fair to good.
