April 29, 2009

Re: Subsurface Exploration  
***Granary at Turner's Creek Landing***  
Kent County, Maryland

**GRANARY AT TURNER'S  
 CREEK LANDING**

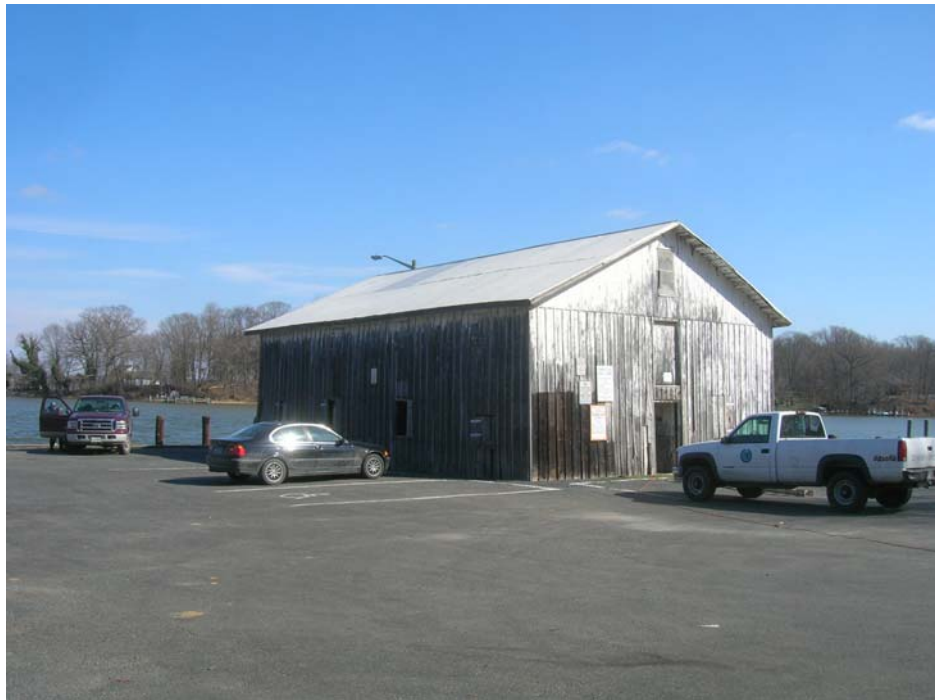
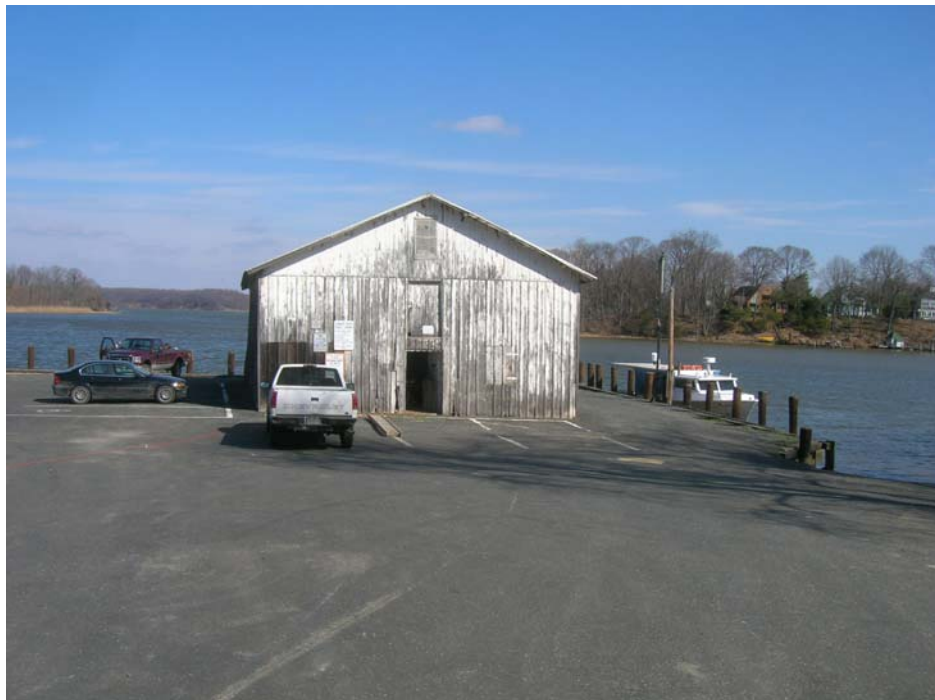
2A

Above: Southwestern view of granary  
 Below: Southern view of granary

landmark. The granary was observed to be a two-story, timber-framed structure with a crawl space. A dry stacked rock foundation was observed along the interior of the southern wall and along a bisecting interior wall, extending east to west. A concrete foundation was observed from the interior of the crawl space under the north wall. It also appears that the sills had been replaced, and the walls had been shimmed in the past. The majority of the wood near the ground surface was observed to be damaged or decayed.

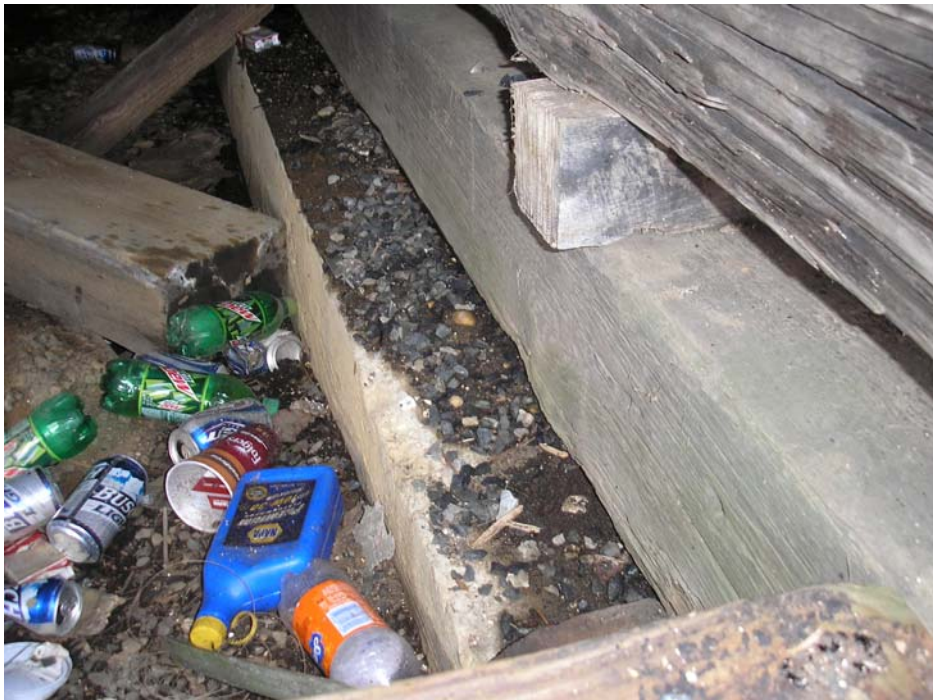
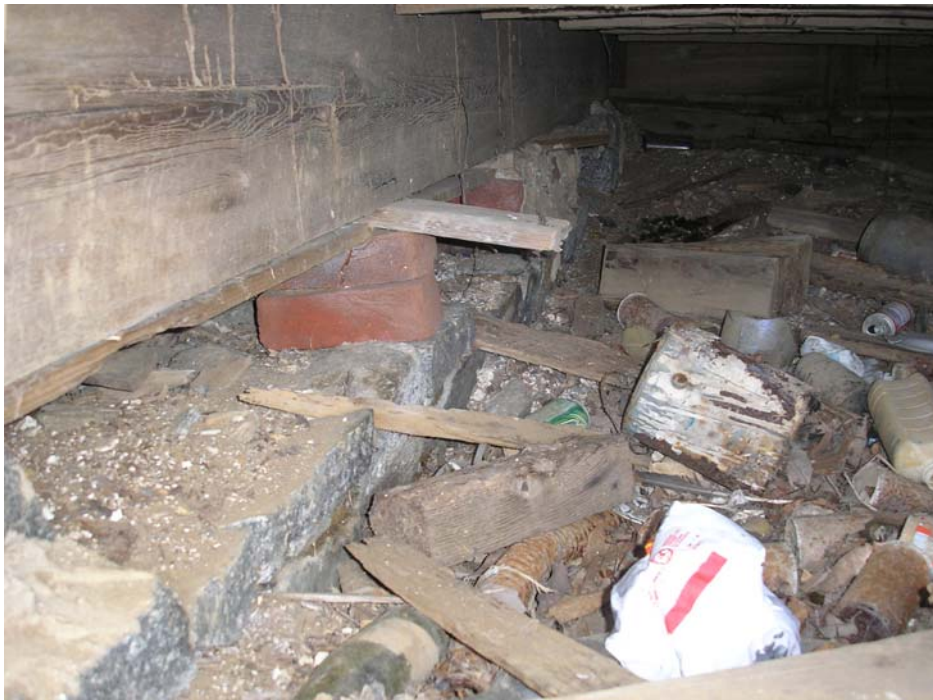
2B

Above: North wall of granary  
 Below: South wall of granary
