CHEN RESIDENCE – DEEP POINT FARM

VARIANCE PACKAGE – BUFFER VARIANCE REQUEST

LOCAL CASE #22-28

4833 Deep Point Drive, Chestertown, MD, 21620

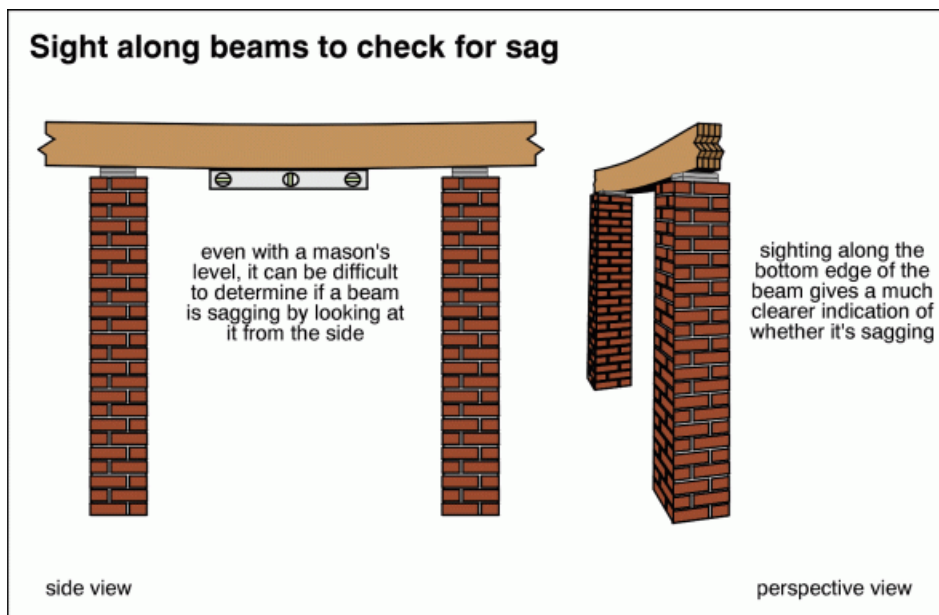
21.

12. Condition: • [Sag](#)

Location: Rear 1st floor library

Task: Repair

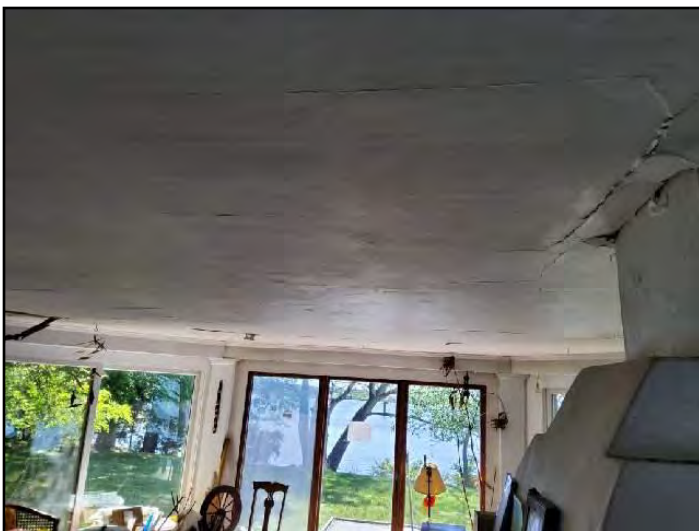
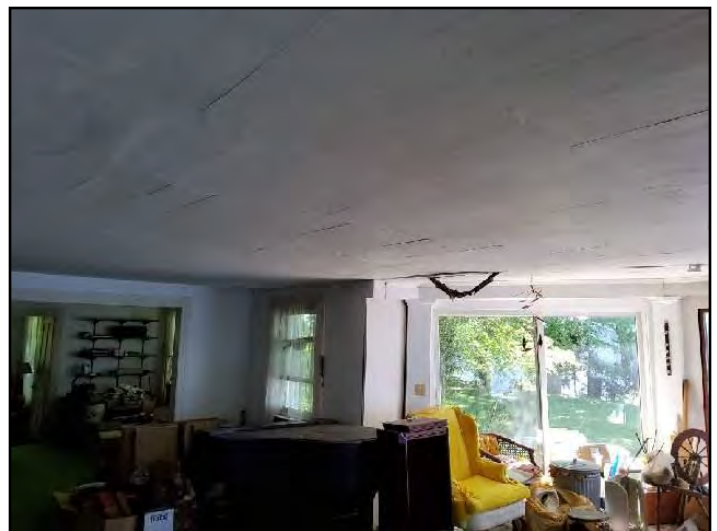
13. Condition: • Sag

The ceiling in the far right sunroom are sagging but cannot view framing to evaluate the cause. Recommend evaluate and repair

Task: Further evaluation and repair

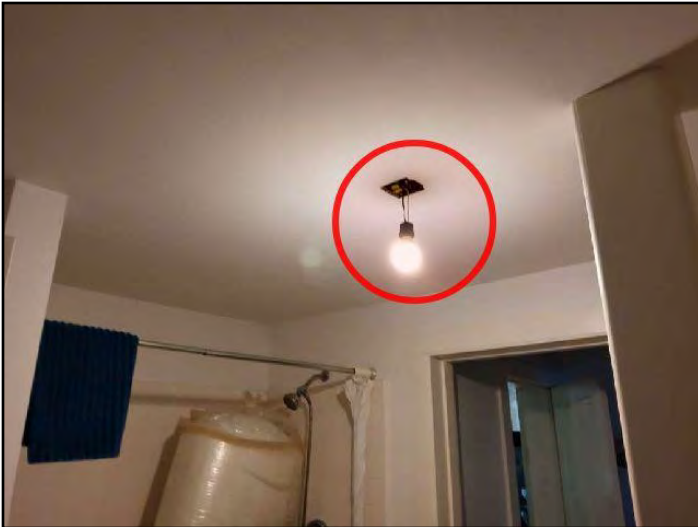
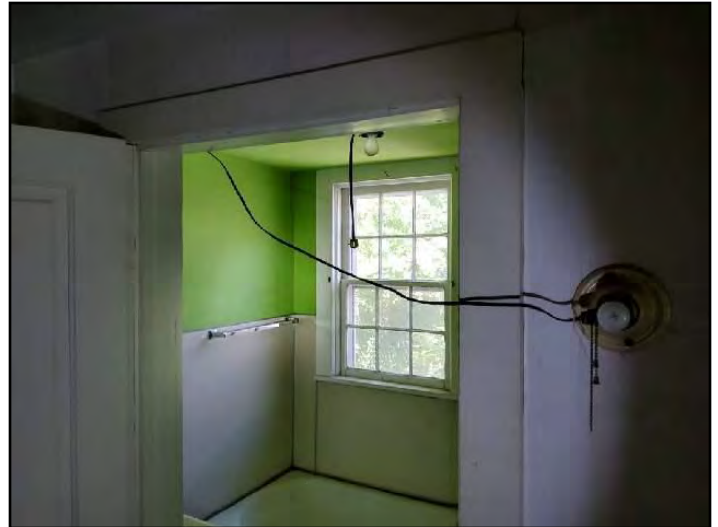
18. Condition: • [Loose](#)

Also improper light wiring

Implication(s): Electric shock | Fire hazard

Location: Various

Task: Repair

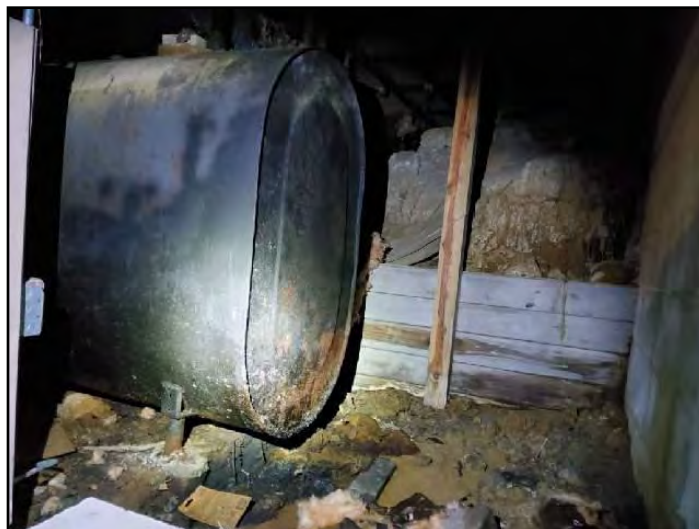
38.

26. Condition: • Rust

The oil tank in the cellar is aging with rust along the bottom, and exterior tank should be removed as it is rusted.

Implication(s): Contamination, fire or explosion

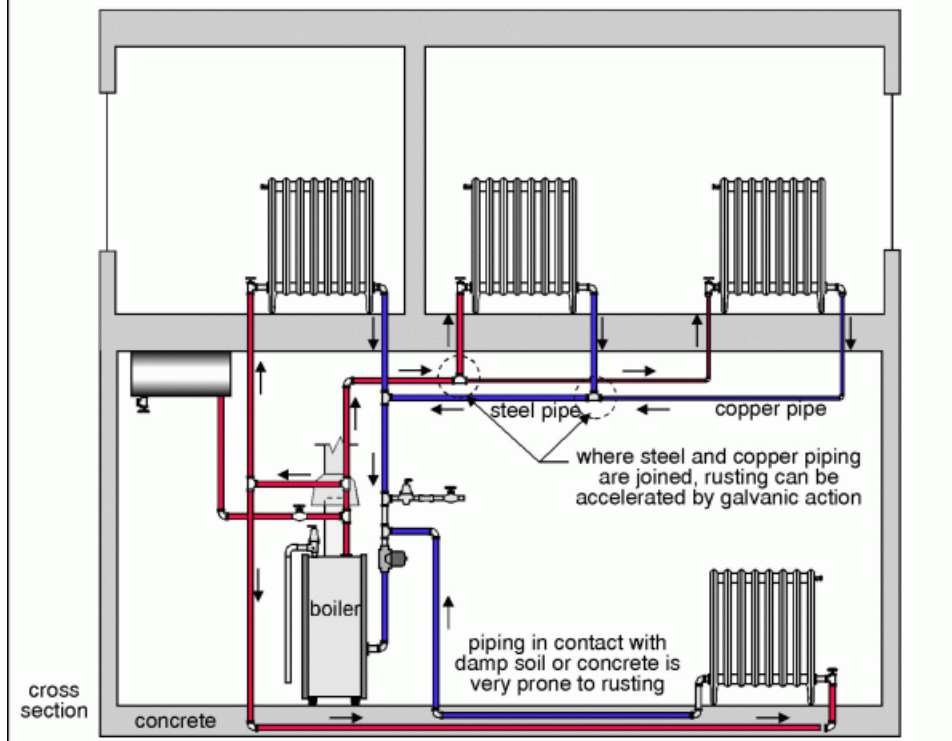
40.

27. Condition: • [Old](#)

The boiler is old but is operating currently.

Pipe corrosion

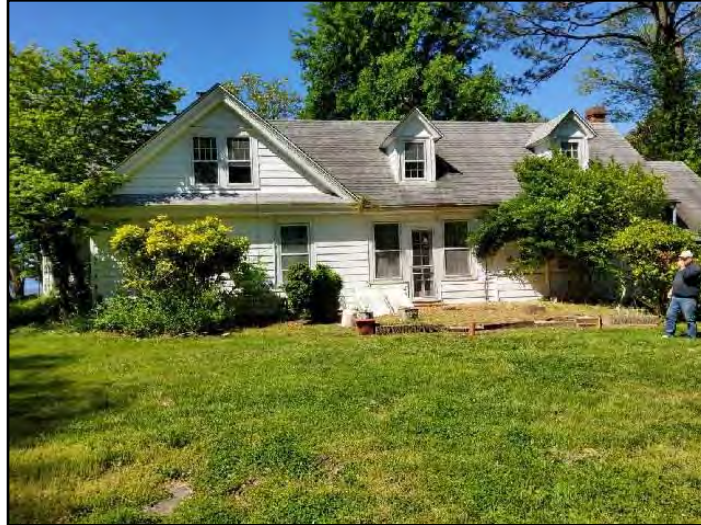
2.

- Rear view of house.

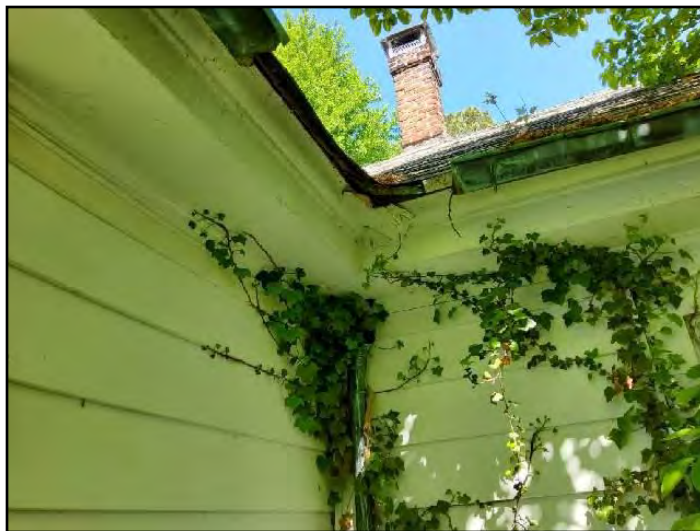
4.

3. Condition: • The exterior has various repairs needed such as flaking trim paint, rot on trim and soffit/rake board, grading needs improved, etc. Recommend an exterior contractor evaluate and repair.

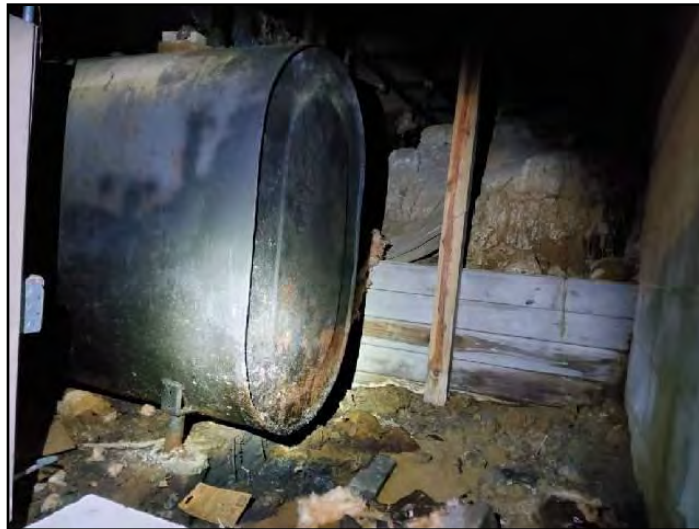
38.

The oil tank in the cellar is aging with rust along the bottom, and exterior tank should be removed as it is rusted.

Implication(s): Contamination, fire or explosion

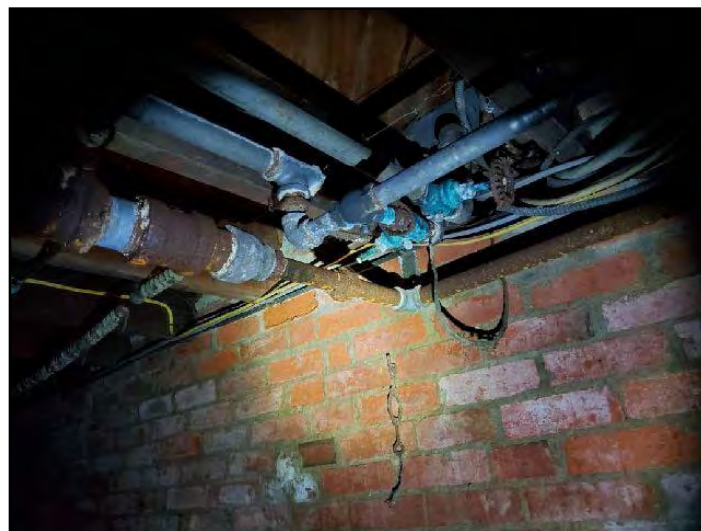
40.

Pipe corrosion

Task: Further evaluation and repair

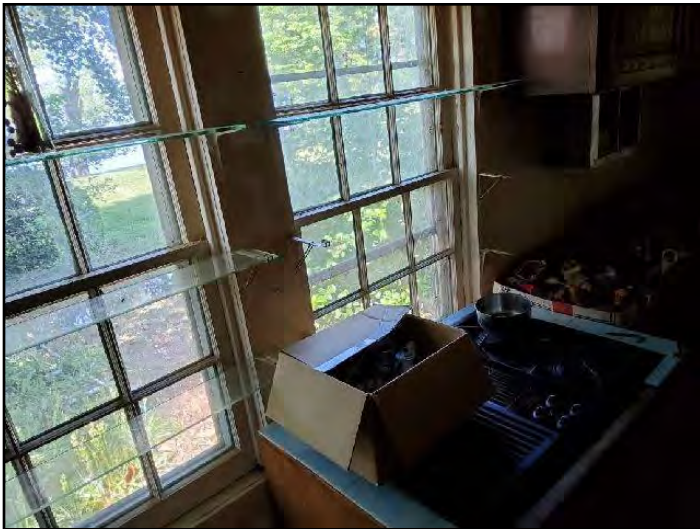
57.

41. Condition: • Many of the windows are in need of repairs or replacement due to broken glass, do not open or are painted shut, and evidence of leaking below multiple. Recommend repair or replace as needed.

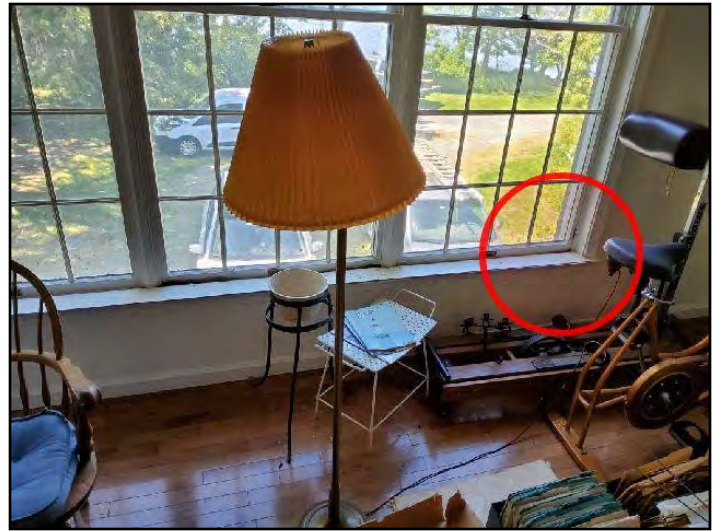
59.

The bottom of 2 of the front living room windows in the garage apt are rotted. Recommend replacing the windows

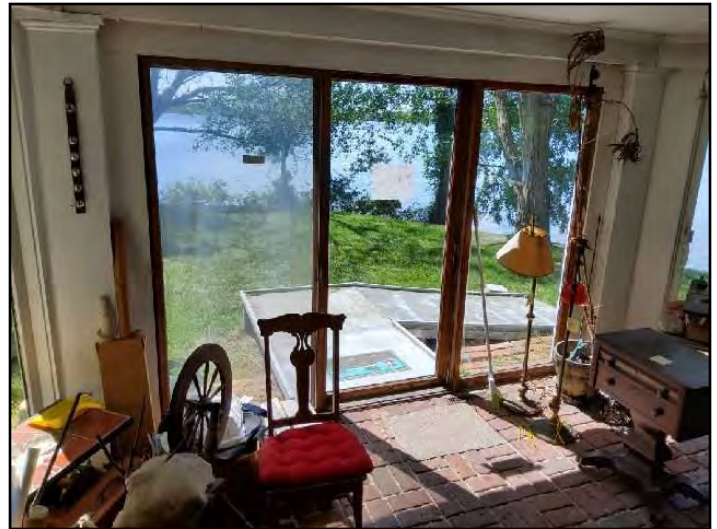
61.

43. Condition: • The old sliding doors in the front and right have water staining on the interior and lost seal between panes. Others have been replaced. Recommend replace older doors.

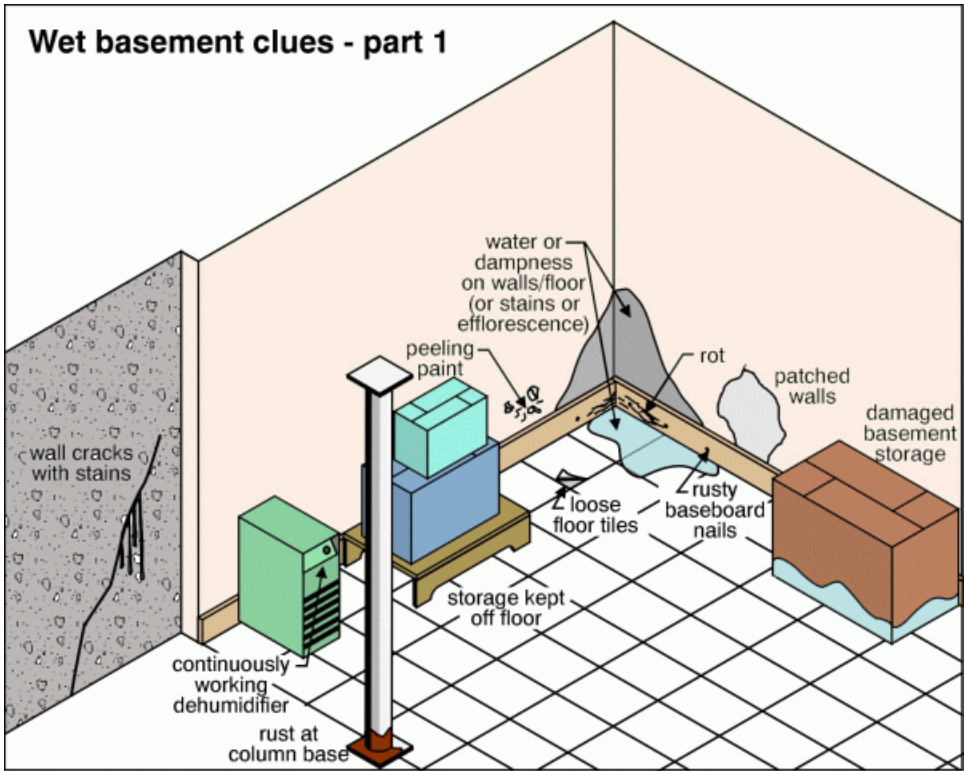
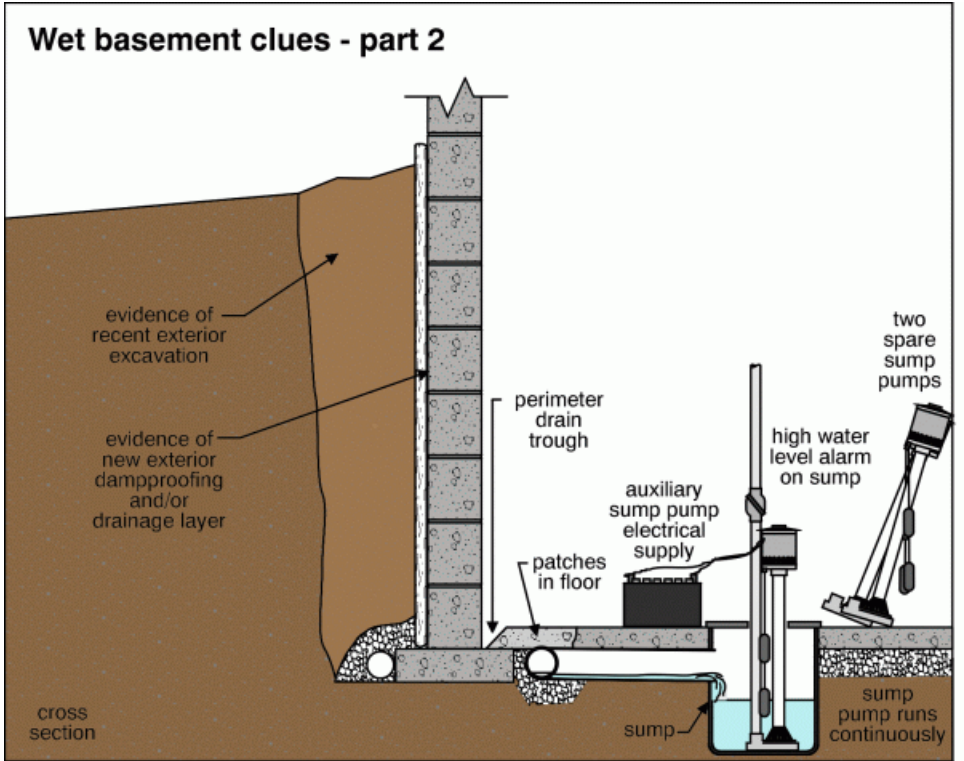
44. Condition: • [Water on floor](#)

The floor of the cellar/basement is mud covered with areas of standing water and apparent mold in various areas. Recommend repair, clean mold, repair exterior grading and drainage, and see structural section for additional recommendations.

Implication(s): Chance of water damage to structure, finishes and contents

Task: Further evaluation and repair
